### Asbestos Sampling Report

Date: 09/07/2022

1401 W. 9<sup>th</sup> St.  
Glenwood Springs, CO 81601

GWS 090122 9th

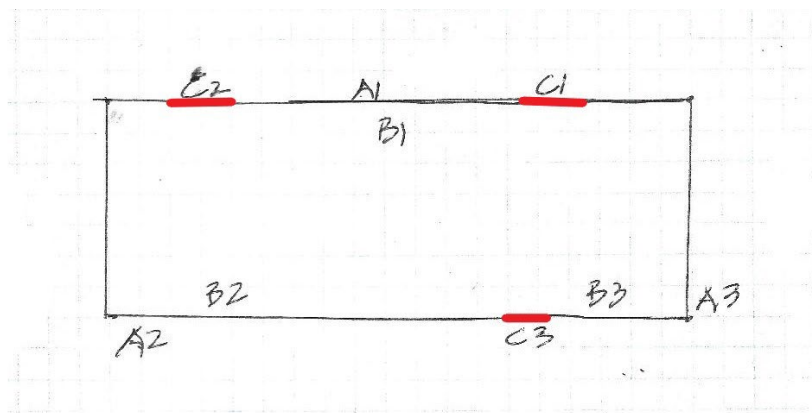
## Sampling Locations

- Spray foam on siding and roof
- Caulking around doors and windows

- The caulking around the doors and windows. Approximately 3 doors and 12 windows.
- These materials are considered non-friable. If the caulking will be rendered friable by mechanical means, then the removal of it is regulated by the CDPHE. If not, then the removal of it is regulated by OSHA. You must consult your landfill to see if they will accept it and how it must be prepared. It may need to be segregated from the other materials so that the landfill may accept it. Element Environmental recommends that an abatement contractor remove these materials to ensure that the workers are trained and that the materials are handled correctly.
