**LIMITED ASBESTOS BUILDING INSPECTION and LEAD
PAINT INSPECTION**

**CDOT Region 3 Maintenance Shop Building
2829 East Shale Drive
Rangely, Colorado 81648**

April 7, 2020
FEI Project No. AS2003-2
CDOT PO# 411023624

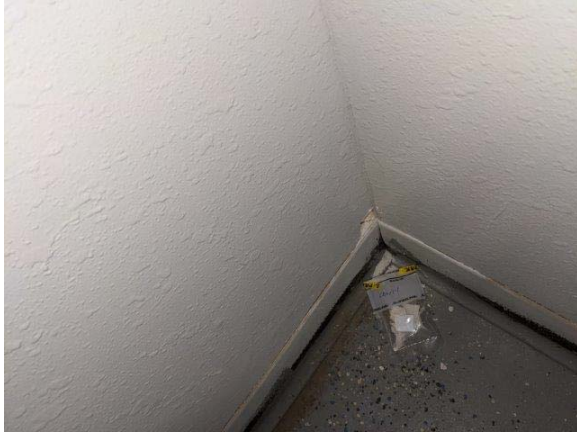
Sample: CDW1-1 - Composite drywall, joint compound and surface texture (orange peel)
Result: Non-Detect

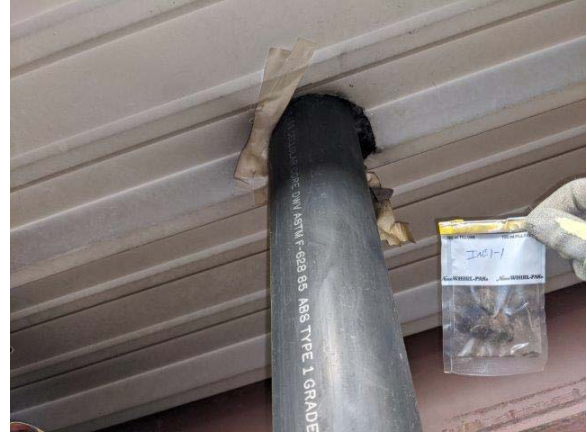
Sample: INS1-1 - Insulation, fiberglass
Result: Non-Detect

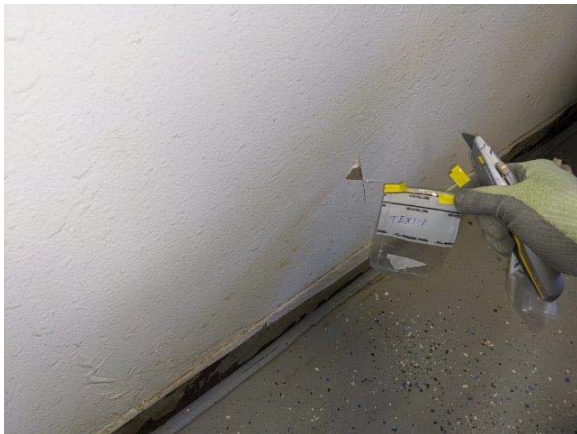
Sample: TEX1-1 - Drywall surface texture (orange peel)
Result: Non-Detect

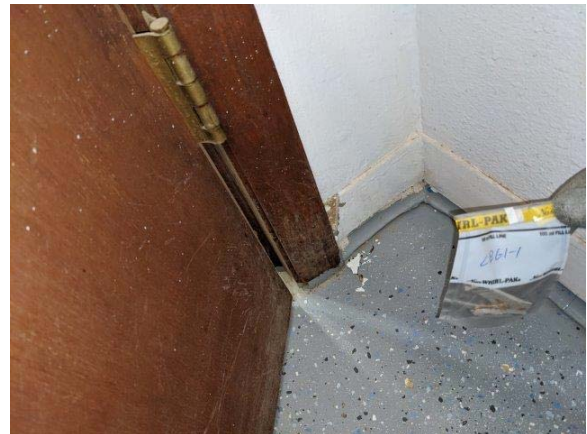
Sample: CBG1-1 - Vinyl cove base, 4" gray with tan mastic
Result: Non-Detect

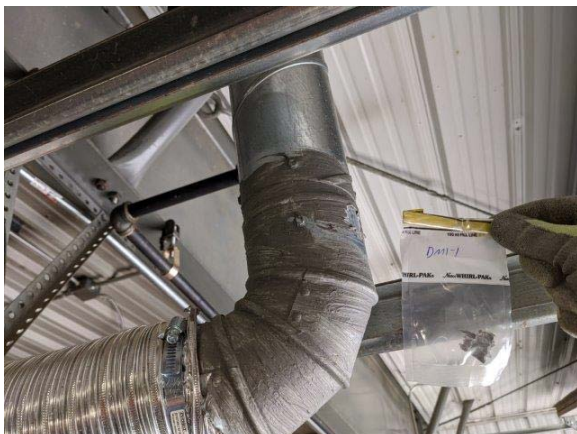
Sample: DM1-1 - Duct mastic, gray
Result: Non-Detect

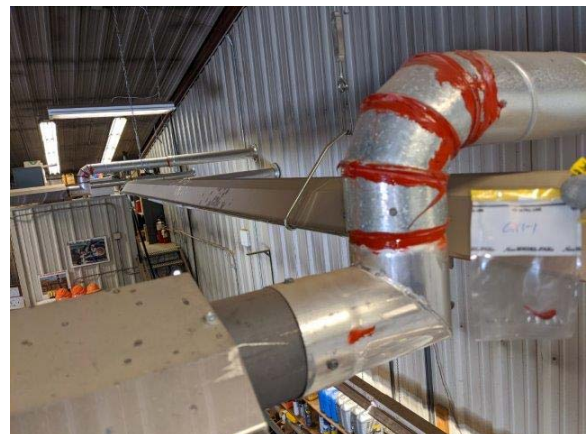
Sample: CK1-1 - Caulk, red
Result: Non-Detect

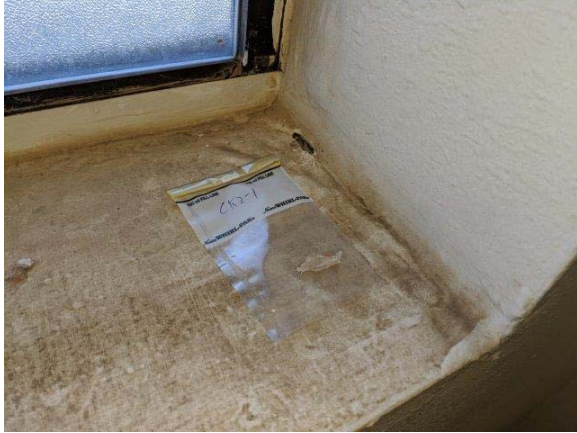
Sample: CK1-1 - Caulk, white
Result: Non-Detect

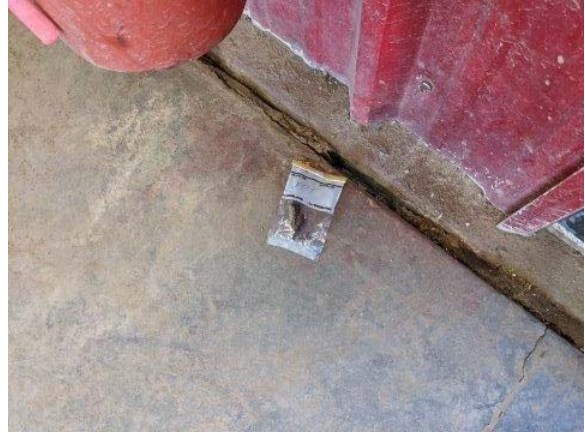
Sample: EJ1-1 - Expansion joint material
Result: Non-Detect

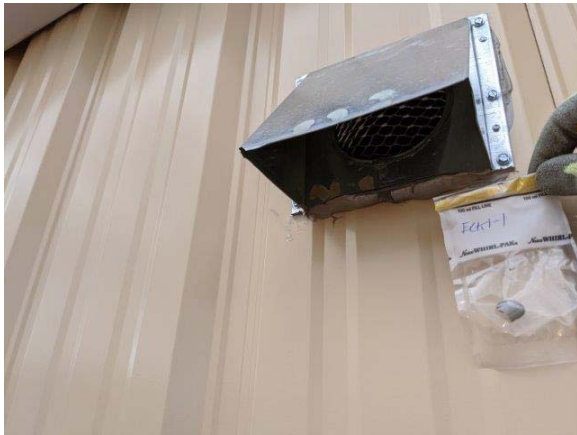
Sample: ECK1-1 - Exterior caulk, silver
Result: Non-Detect

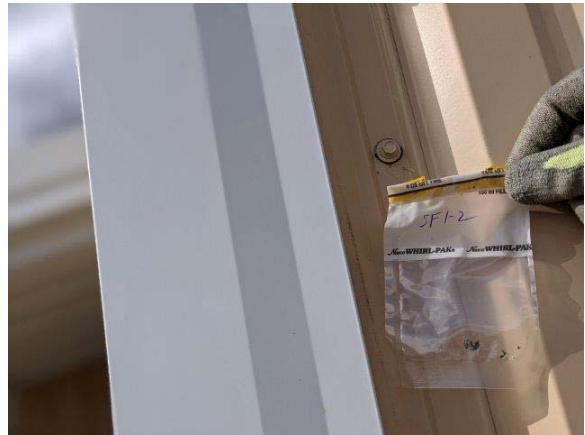
Sample: SF1-2 - Screw flashing
Result: Non-Detect

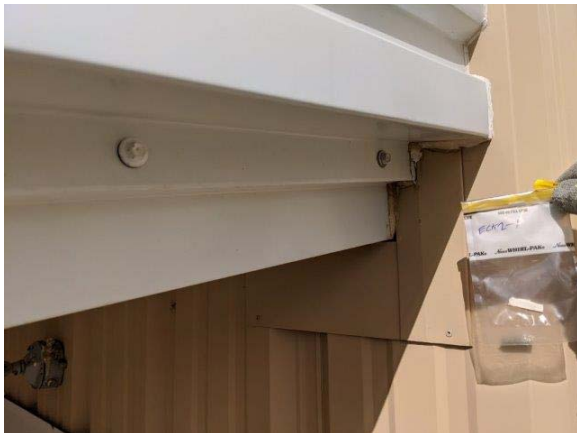
Sample: ECK2-1 - Exterior caulk, white
Result: Non-Detect

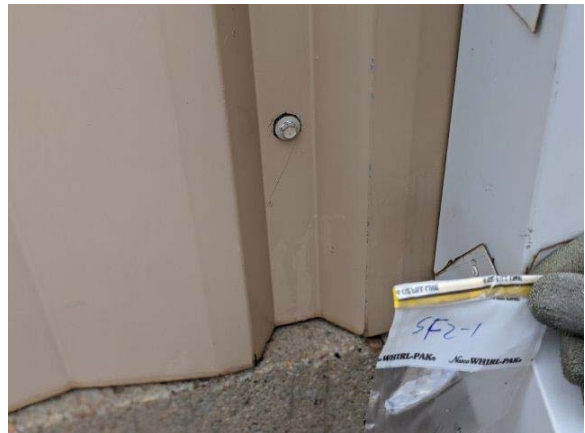
Sample: SF2-1 - Screw flashing
Result: Non-Detect

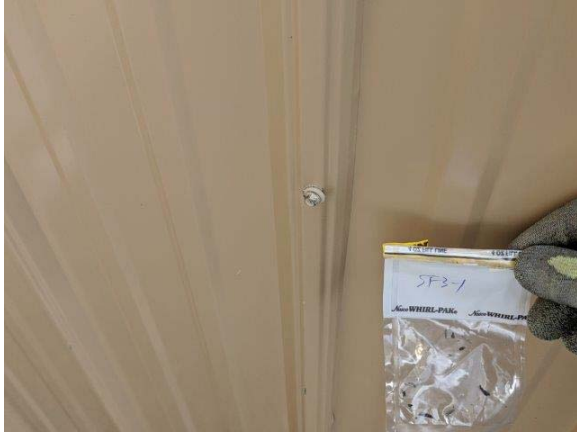
Sample: SF3-1 - Screw flashing
Result: Non-Detect

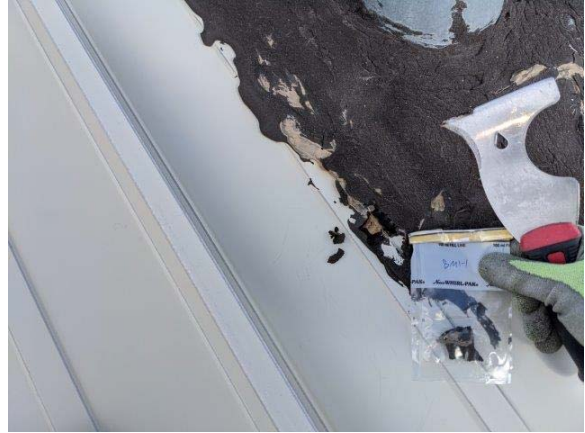
Sample: BM1-1 - Black roofing mastic
Result: Non-Detect

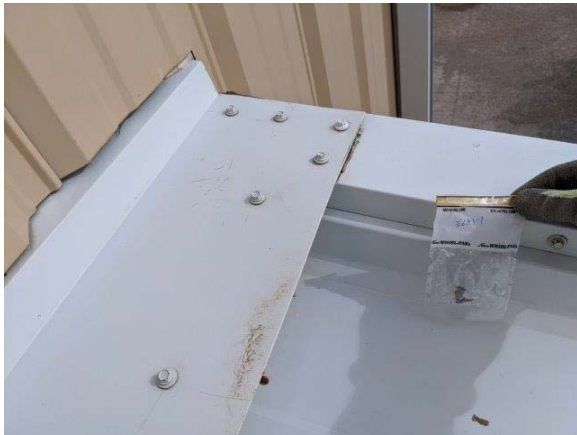
Sample: ECK3-1 - Exterior caulk, butyl gray
Result: Non-Detect

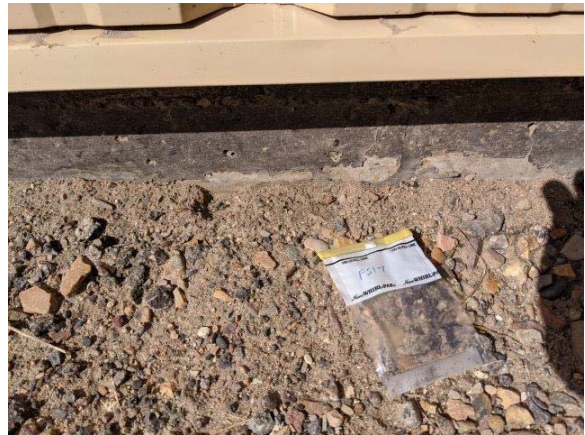
Sample: FS1-1 - Foundation sealant, black
Result: Non-Detect

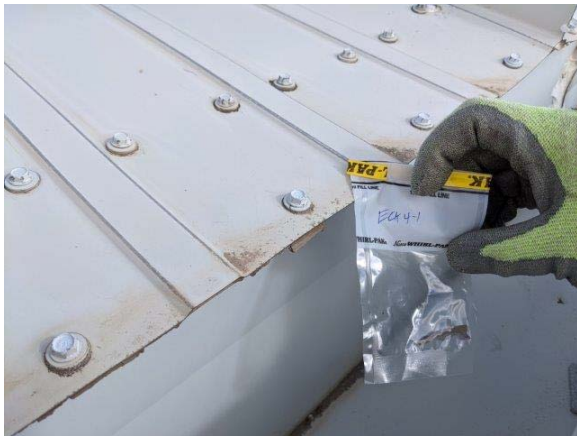
Sample: ECK4-1 - Exterior caulk, butyl gray
Result: Non-Detect

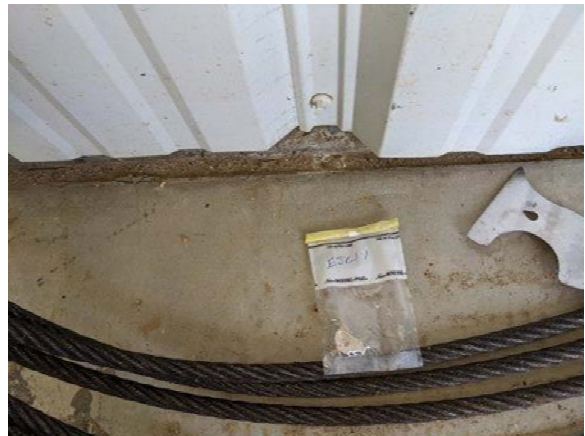
Sample: EJC1-1 - Expansion joint caulk, light gray
Result: Non-Detect
