White River National Forest Aspen Sopris Ranger District

Aspen-Sopris Ranger District Office

Proposed Aspen-Sopris District Office & Work Compound Site Development Carbondale Site Carbondale, Colorado June 29, 2018 Terracon Project No. 25185026

Re: Geotechnical Engineering Report Proposed Aspen-Sopris District Office & Work Compound Site Development Carbondale Site 620 Main Street Carbondale, Colorado Terracon Project No. 25185026

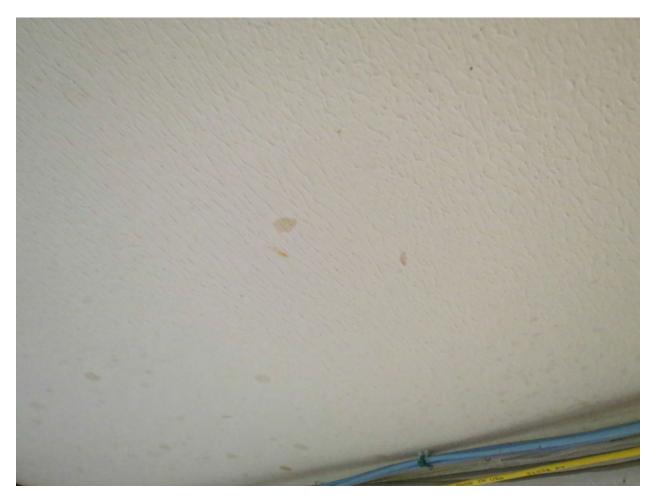
The asbestos-containing roll-applied drywall ceiling texture was observed on the drywall ceiling in the original (older) portion of the Ranger's Office Building basement.

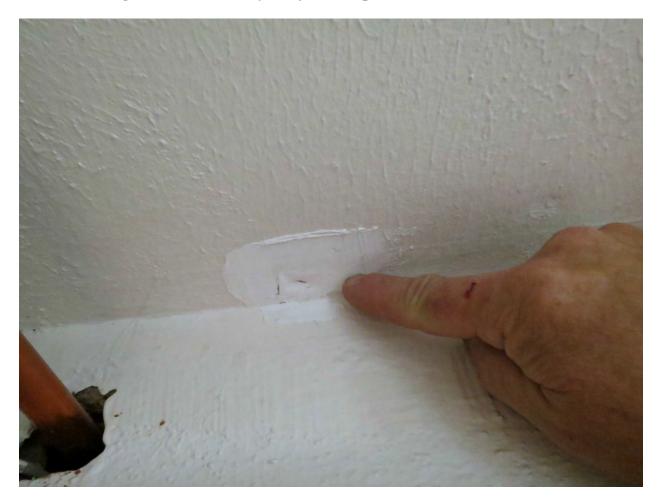
Photo of Homogeneous Area #9, drywall joint compound:

Material Description: **Drywall joint compound** Type of Material: **Miscellaneous Material** Friability: **Friable** Material Condition: **Good**

The asbestos-containing drywall joint compound was observed on the drywall ceiling in the original (older) portion of the Ranger's Office Building basement.

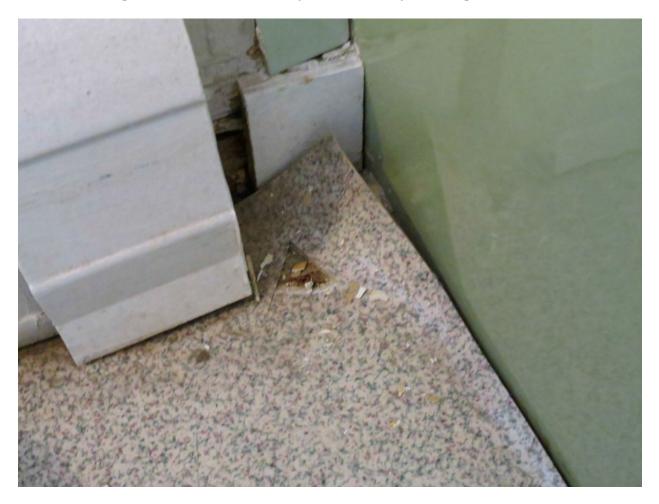
Photo of Homogeneous Area #14, multilayered sheet vinyl flooring:

Material Description: **Multi-layered sheet vinyl flooring** Type of Material: **Miscellaneous Material** Friability: **Friable** Material Condition: **Good** Frequency of Potential Contact: **High** Influence of Vibration: **Low** Potential for Air Erosion: **Low**

<u>Material Location</u> Ranger's Office Build East Bathroom	Material Quantity ding, Approx. 50 sq. ft.	<u>AHERA Category</u> #6-ACBM with potential for significant damage
<u>Sample No.</u> 14-1	Sample Location Ranger's Office Building, East Bathroom floor, Northeast corner	Asbestos Composition 25% Chrysotile
14-2	Ranger's Office Building, East Bathroom floor Southeast corner Behind toilet	25% Chrysotile

The multi-layered sheet vinyl flooring must be removed by personnel trained and certified to remove, transport and dispose of asbestos-containing material prior to demolition of the building, or if renovation activities will disturb the material.

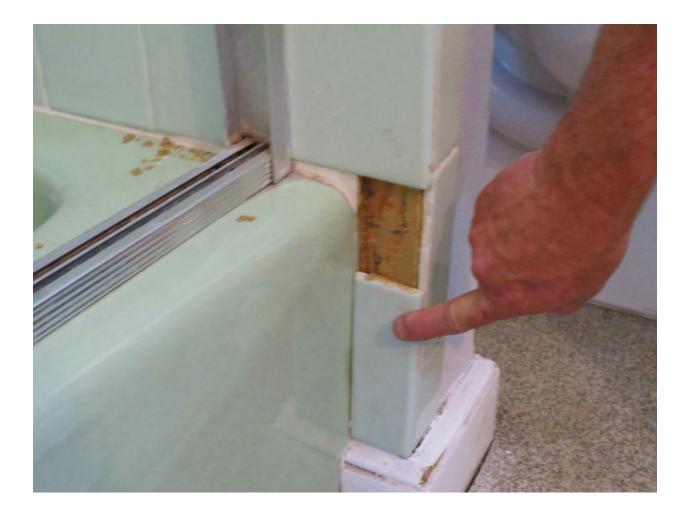
Photo of Homogeneous Area #15, tan adhesive (behind green ceramic tiles):

Material Description: **Tan adhesive (behind green ceramic tiles)** Type of Material: **Miscellaneous Material** Friability: **Non-Friable** Material Condition: **Good** Frequency of Potential Contact: **Low** Influence of Vibration: **Low** Potential for Air Erosion: **Low**

Material Location Ranger's Office Build East bathroom	Material Quantity ding, Approx. 50 sq. ft.	<u>AHERA Category</u> Non-friable ACBM
<u>Sample No.</u> 15-1	Sample Location Ranger's Office Building, East bathroom, Above SW corner of tub	Asbestos Composition 2% Chrysotile (brown adhesive) None Detected (ceramic tile)
15-2	Ranger's Office Building, East bathroom, Above northwest corner of tub	2% Chrysotile (brown adhesive) None Detected (ceramic tile)

The CDPHE allows non-friable asbestos-containing adhesive to remain in a building during demolition of the building provided the material will remain non-friable during the demolition process. No amount of the non-friable adhesive may remain at the site or in the soil after the demolition has been completed. All debris generated during the demolition of the building must leave the site and go to a landfill that will accept demolition debris that contains non-friable asbestos-containing materials.

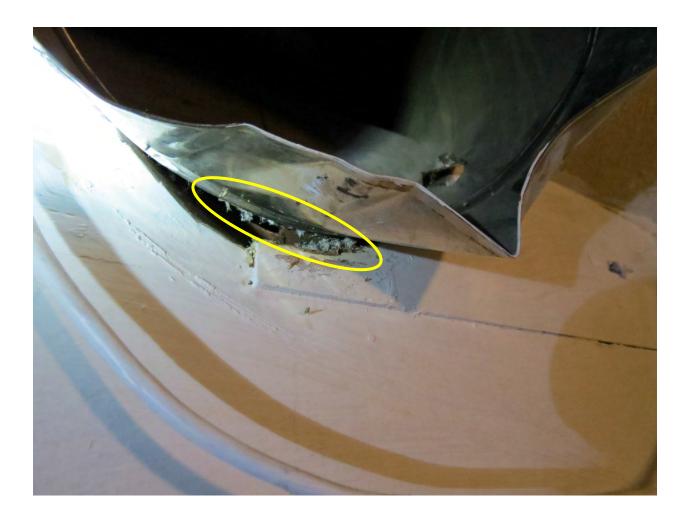
Photo of Homogeneous Area #29, white fibrous duct insulation:

Material Description: White fibrous duct insulation Type of Material: Thermal System Insulation Friability: Friable Material Condition: Good

<u>Potential for Disturbance</u> Frequency of Potential Contact: Low Influence of Vibration: Medium Potential for Air Erosion: Medium

The white fibrous duct insulation must be removed by a licensed General Abatement Contractor utilizing personnel trained and certified to remove, transport and dispose of asbestos-containing material prior to demolition of the building or if the materials will be disturbed during renovation activities.

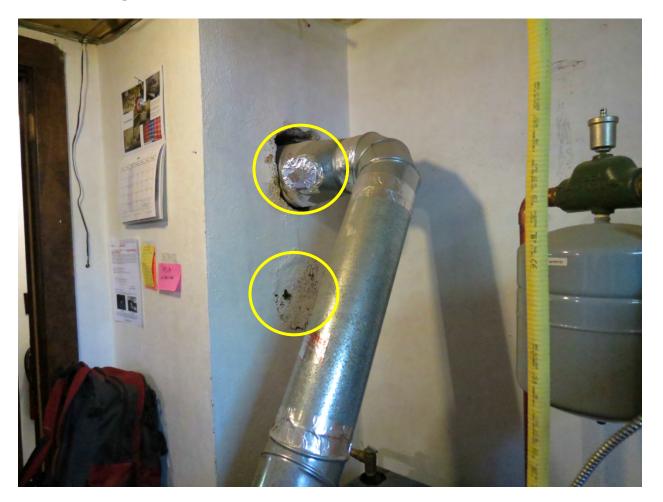
Photo of Homogeneous Area #30, brown fibrous insulation:

Material Description: **Brown fibrous insulation** Type of Material: **Thermal System Insulation** Friability: **Friable** Material Condition: **Good**

<u>Potential for Disturbance</u> Frequency of Potential Contact: **Medium** Influence of Vibration: **Medium** Potential for Air Erosion: **Medium**

The brown fibrous insulation must be removed by a licensed General Abatement Contractor utilizing personnel trained and certified to remove, transport and dispose of asbestos-containing material prior to demolition of the building or if the materials will be disturbed during renovation activities.

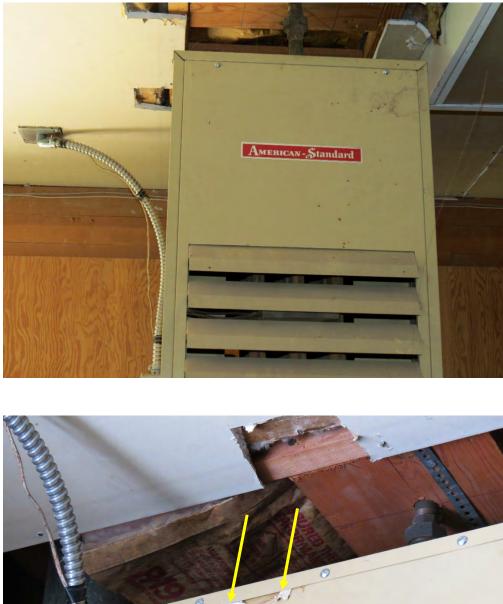
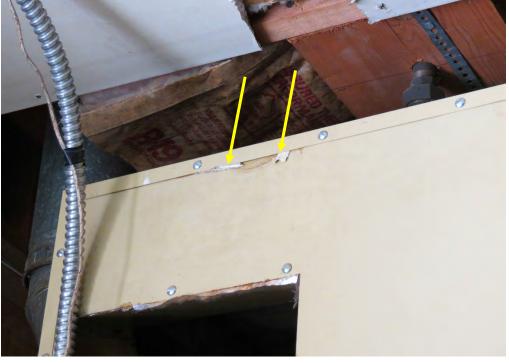
Photos of Homogeneous Area #36, white woven gasket:

Material Description: White woven gasket Type of Material: Miscellaneous Material Friability: Non-Friable Material Condition: Good

<u>Potential for Disturbance</u> Frequency of Potential Contact: **Low** Influence of Vibration: **Low** Potential for Air Erosion: **Low**

The white woven gasket is considered non-friable. Do not sand, grind, drill or abrade the material. Should the material become damaged or disturbed, removal should be performed using proper procedures utilizing personnel trained in asbestos removal techniques and personal protective equipment. Properly maintained asbestos containing woven gaskets pose minimal risk of fiber release.

The white woven gasket may become friable during demolition and the gasket must be removed by a licensed General Abatement Contractor utilizing personnel trained and certified to remove, transport and dispose of asbestos-containing material prior to demolition of the building or if the material will be disturbed during renovation activities.

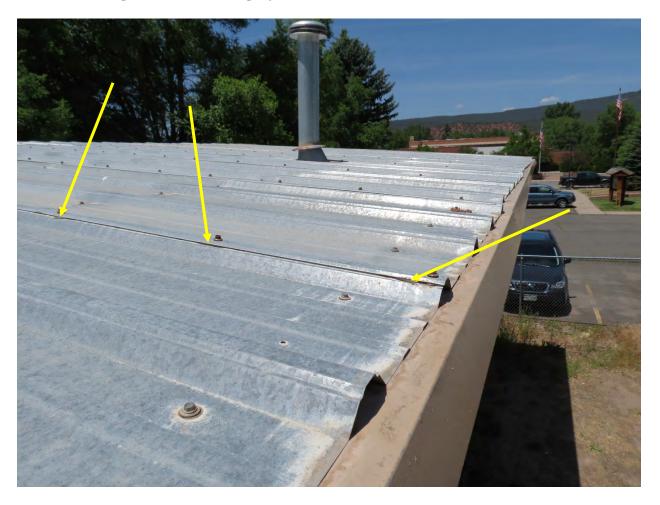
Photo of Homogeneous Area #43, gray caulk:

Material Description: Gray Caulk Type of Material: Miscellaneous Material Friability: Non-Friable Material Condition: Good Frequency of Potential Contact: Low Influence of Vibration: Low Potential for Air Erosion: Low

Material Location Warehouse Building	Material Quantity Approx. 700 ln. ft.	<u>AHERA Category</u> Non-friable ACBM
Sample No. 43-1	Sample Location Warehouse Building, Roof, East side, Center	Asbestos Composition 5% Chrysotile
43-1	Warehouse Building, Roof, East side, South of center	5% Chrysotile

The CDPHE allows non-friable asbestos-containing caulk to remain in a building during demolition of the building provided the material will remain non-friable during the demolition process. No amount of the non-friable caulk may remain at the site or in the soil after the demolition has been completed. All debris generated during the demolition of the building must leave the site and go to a landfill that will accept demolition debris that contains non-friable asbestos-containing materials.
